Case study

- TEM and PLM analysis of small, 3 dimensional, asbestos containing materials
 - Thermal System Insulation
 - Surfacing Material

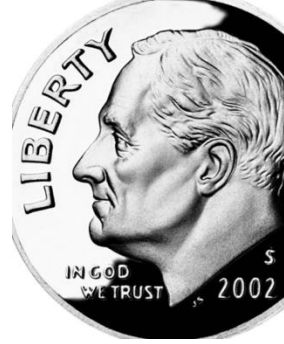
General Size of Asbestos Fiber

- Asbestos fibers range in size from **.1 to 10 microns** in length (a human hair is about 50 microns in diameter).
 - Example with assumptions
 - Width typically is 3:1 ratio (very large) (5 microns Length = 1.66 microns width)
 - Volume : $1.08e-5 \text{ mm}^3 / 0.0108 \text{ microns}$
- Size of Dime
 - 17.19 mm / 17910 microns in length
 - Volume: $340.24 \text{ millimeters}^3 / 340,110 \text{ microns}^3$
- So theoretically **31,491,666** asbestos fiber can be in the volume of a dime.

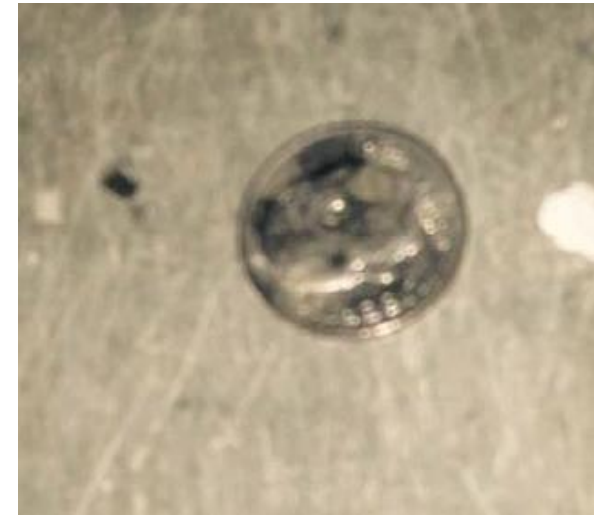
Thermal System Insulation

- TSI from steam pipes
 - TEM Results

Laboratory Sample	Customer Sample Number	Asbestos Components (%)	Non-Asbestos Components (%)
316605001	Bulk-TSI-1	Chrysotile 10-20%	Other 80-90%

- ACM material appears to be .25% of dime
 - 10-20% of material contains asbestos (15%)
 - **2,165,052** fiber theoretically can be in the picture shown above.

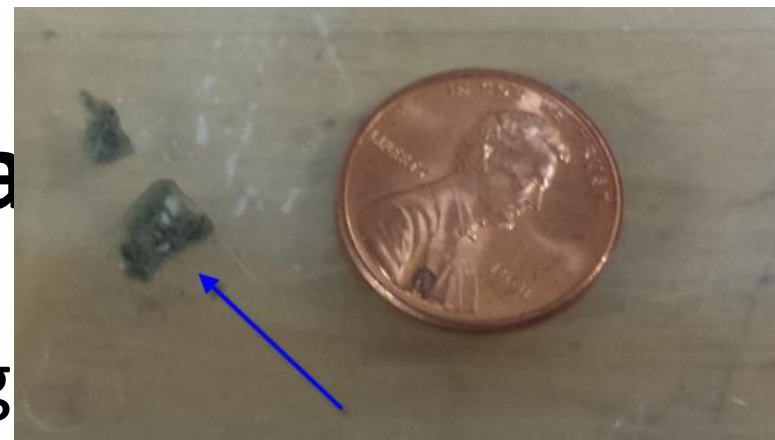
Surfacing Ma

- Surfacing Material covering

Laboratory Sample	Customer Sample Number	Asbestos Components (%)	Non-Asbestos Components (%)
316661001	20141114-01	Chrysotile 15-20% Amosite 5-10%	Other 70-75%

- ACM material appears to be $\sim .25\%$ of penny
 - 25-30% of material contains asbestos (27.5%)
 - **1,180,937** fibers theoretically can be in the picture shown above.
